CELL :- D.C. CELL NAME:-Drum change All models MACHINE / STAGE:- VMC spark machine. OPERATION:- 5-Hole drilling.

KAIZEN THEME :- To increase the MTBF of Hole Seal.

IDEA :-To make Bush from PU material

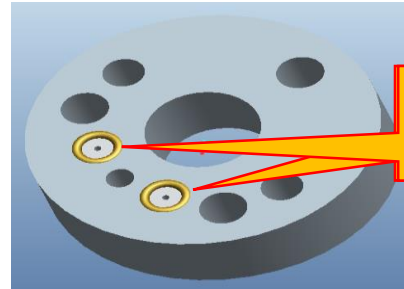
BEFORE

PROBLEM / PRESENT STATUS:-We had provided a O ring to prevent the 5 hole depth oversize But O ring removed from hole in every 2 hours.Aprox.

'O' ring

- WHY 1:- O ring removed in every 2 hours.Aprox.
- WHY 2:- Which was not fixed with hole.
- WHY 3:-It was made from rubber material.

ROOT CAUSE :- O Ring made from Rubber material

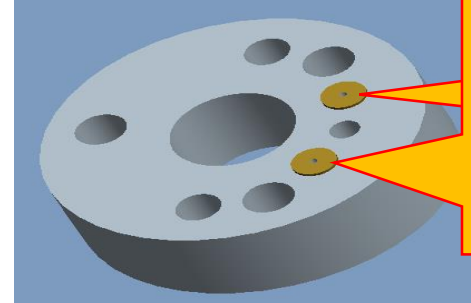
AFTER

'PU Bush' provided in Resting Ring in which air pass which is used for prevention of 5-hole depth over size.

COUNTERMEASURE:-Changed the o ring of Rubber and using PU bush at Drilling & Tapping A352 & A422 Resting ring above the metallic face of 5-hole drilling fixture, then if any metallic chips comes on the drilling fixture then air pressure not drop and reach the specific pressure which use for prevention of 5 depth over size of drum change all models
