REGISTRATION NO. & DATE: 796 & 20.08.15.

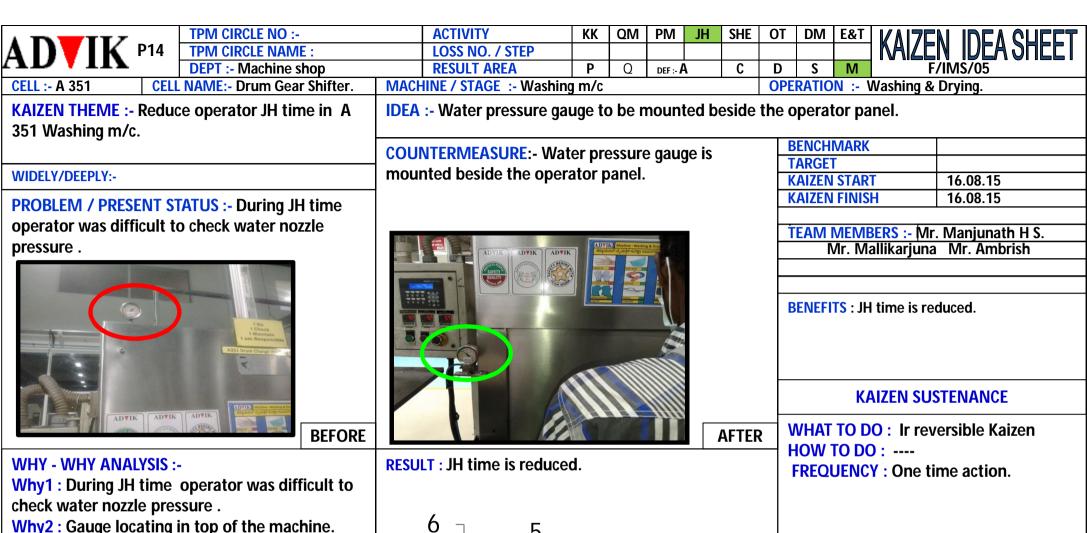
ROOT CAUSE:-Gauge locating in top of the machine.
