**CELL :-** Soft line      **CELL NAME :-** Drum gear      **M/C STAGE :-** Retaping      **OPERATION :-** Retaping

**KAIZEN THEME :-** Increase the MTBF

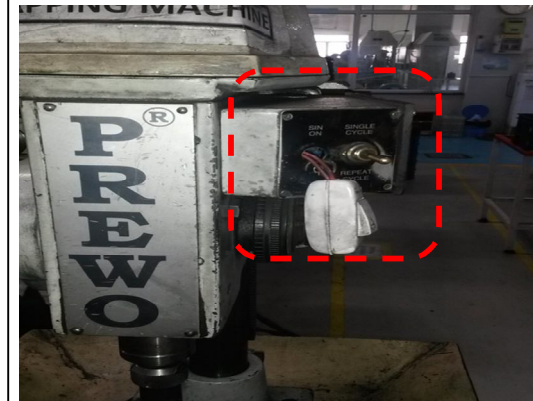
BEFORE

**PROBLEM / PRESENT STATES:-** sin type switch provided, so damaging once in every 6 months.

**ROOT CAUSE :-** Weak design

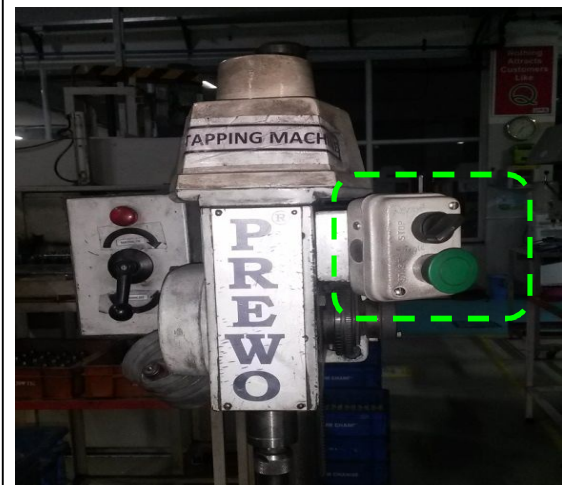
AFTER

**RESULT:-** No breakage of P.B

**COUNTERMEASURE:-** Replaced the sin type switch by standard P.B.
