CELL :- A410 CELL NAME:- oil pump MACHINE / STAGE :- VMC OPERATION :- Reaming

KAIZEN THEME -To avoid A410 Body Dowel hole shift

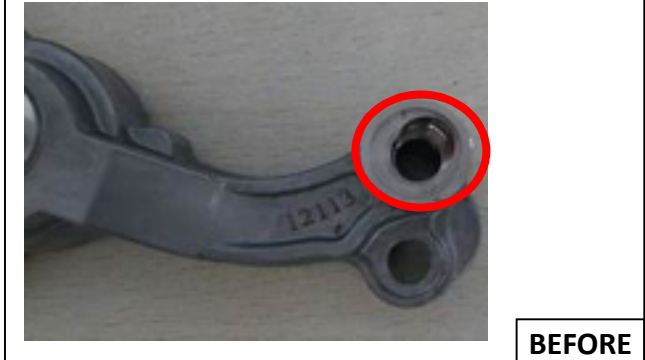
BEFORE

PROBLEM / PRESENT STATUS -A410 Body Dowel hole shift

WHY - WHY ANALYSIS :-
Why 1 – A410 Body Dowel hole shift.
Why 2 – In 2nd set up, part not load on dowel pin & operation done .
Why3 – Current process allows wrong loading .

ROOT CAUSE- -- Current process allows to wrong load.
