**CELL :-** A420    **CELL NAME:-** Oil Pump Assy.    **MACHINE / STAGE :-** Oil Pump Assembly Line    **OPERATION :-** Shaft Assembly Stage

**KAIZEN THEME :** To Prevent re-occurrence of wrong position of Shaft assembly in A420 oil pump Assembly

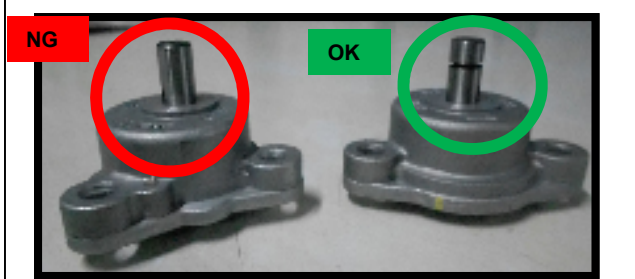
**BEFORE**

**PROBLEM / PRESENT STATUS :-** During assembly wrong position of Shaft assembly in A420 Oil Pump.

No provision in fixture to arrest wrong position shaft assembly

- Why 1:** Shaft position wrong during assy
- Why 2:** Existing process allow to pass such type of defects
- Why 3:** No provision to arrest wrong position of shaft during assy.
- Why 4:** Poka.

**ROOT CAUSE :-** Poka
