CELL :- A261 CELL NAME:- Flyweight MACHINE / STAGE :- Drilling /VMC OPERATION :- Reaming

KAIZEN THEME –To eliminate A261 Fly weight Perpendicularity NG.

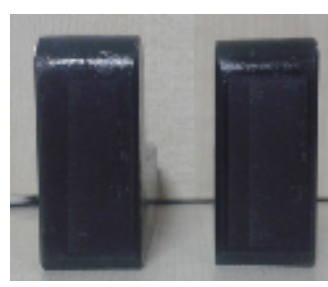
BEFORE

PROBLEM / PRESENT STATUS –A261 Fly weight Perpendicularity NG spec 0.015mm, Actual 0.1mm .

Clamping pad wear out

WHY - WHY ANALYSIS :-
Why 1 – A261 Fly weight Perpendicularity NG.
Why 2 – Reaming operation not perpendicular to resting face.
Why:3 - Resting face inclined wrt reamer axis.
Why 4: After clamping part gets tilt.
Why 5 – Uneven clamping due to weak clamp design .

ROOT CAUSE- -Uneven clamping due to weak clamp design .
