CELL :- A 247 BKT	CELL NAME:- BKT	MACHINE / STAGE :- Drilling	OPERATION : Drilling
-------------------	-----------------	-----------------------------	----------------------

**KAIZEN THEME –To avoid** A247 Bracket 8.1 Hole Oversize Spec 8.1±0.2 & actual 8.35mm ( No Go PPG Qualify )

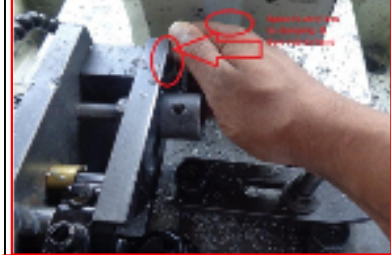
**PROBLEM / PRESENT STATUS -A247**  
Bracket 8.1 Hole Oversize Spec 8.1±0.2 & actual 8.35mm ( No Go PPG Qualify

Difficult to tightening, During regular production ( operator fatigue )

**Why 1** – A247 Bracket 8.1 Hole Oversize. (Spec 8.1 0± 0.2 ,Actual 8.35).

**Why 2** – Part vibrate during Drilling operation .

**Why 3** – Part not clamp properly by operator .

**Why 4** – During clamping in regular process operator hands touch to fixture edge ( Operator fatigue )

**ROOT CAUSE-** – During clamping in regular process operator hands touch to fixture edge ( Operator fatigue )

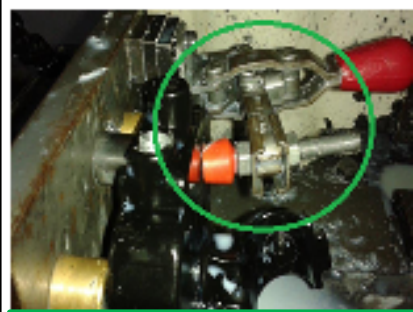
Toggle Clamping to be provided to avoid operator mistake

**IDEA :-** Pokayoke to be implemented ( Toggle clamping to be provide ).

**COUNTERMEASURE:-** 1) Toggle clamping clamping to be provide. 2) 100 % checking started for 8.1 Inside dia .
