CELL :- A211 CELL NAME:- Tensioner MACHINE / STAGE :- SPM OPERATION : Drilling

KAIZEN THEME -To avoid A211 Body Dia 2.5 shift

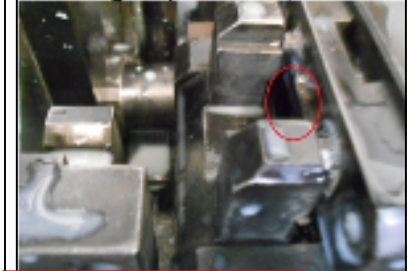
BEFORE

PROBLEM / PRESENT STATUS -6 No's -A247 BKT Dia 4.2 Depth through out. Spec 14.5±0.2 & actual through out .(Setting rejection)

No guide plate

WHY - WHY ANALYSIS :-
Why 1 – A211 Body Dia 2.5 shift .
Why 2 –During loading part get shift downward side & part clamp .
Why 3 – During loading operator should be load part in pin .but by mistake operator loading not properly
Why 4 –Current process allowed to wrong loading & No pokayoka to avoid wrong loading

ROOT CAUSE- Current process allowed to wrong loading & No pokayoka to avoid wrong loading

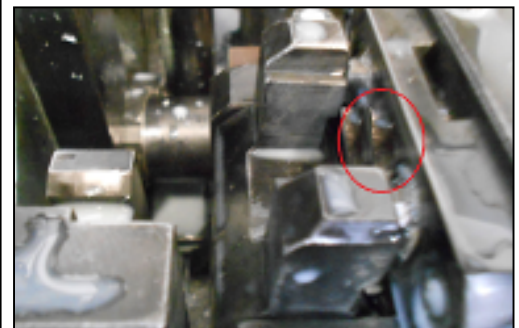
AFTER

Guide plate

COUNTERMEASURE:- 1) Resting plate added in fixture to avoid wrong loading
