CELL :- A247 L	CELL NAME:- Lever	MACHINE / STAGE :- SPM	OPERATION :-Tapping
----------------	-------------------	------------------------	---------------------

KAIZEN THEME -To Avoid A247 Lever Ø 6.3 hole shift.

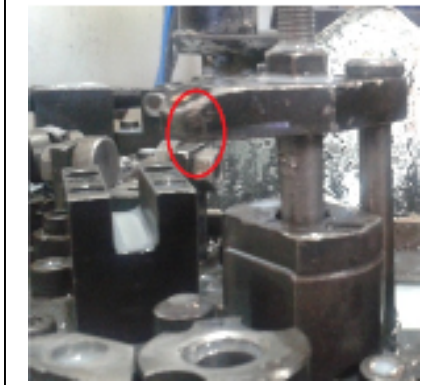
BEFORE

PROBLEM / PRESENT STATUS -A247 Lever Ø 6.3 hole shift.

- WHY - WHY ANALYSIS :-**
- Why 1** - A247 Lever Ø 6.3 hole shift.
 - Why 2** - Part not clamp.
 - Why 3** - Clamp pad broken.
 - Why 4** - Excess load act on pad.
 - Why 5** - Gap between clamp strip & clamping pad.

ROOT CAUSE- Gap between clamp strip & clamping pad
