CELL :-Assy CELL NAME:-A337/271 M/C STAGE :-Oil Pump OPERATION :-Free Rotation & Flushing

KAIZEN THEME :- MTBF to be improve

IDEA :- Stopper location to be shift

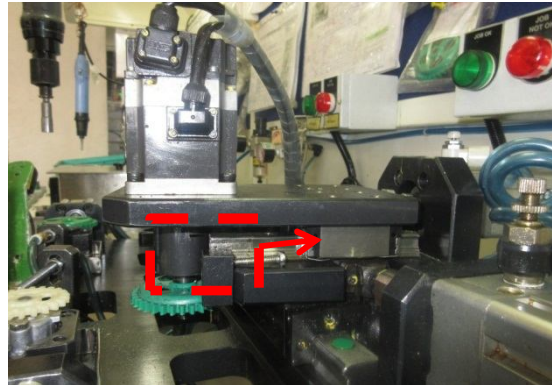
BEFORE

PROBLEM / PRESENT STATES:- Stopper provided at the bottom side of cylinder for stroke control which is getting direct contact with LM guide, it intern causing damage on LM guide, & even Hard to set while setup change as there is less space for hand movement.

- Why1 :-** Shifted the location of stopper.
- Why2 :-** Slide getting jam
- Why3 :-** Lm guide damage
- Why4 :-** Direct contact with the stopper

ROOT CAUSE :- wrong design

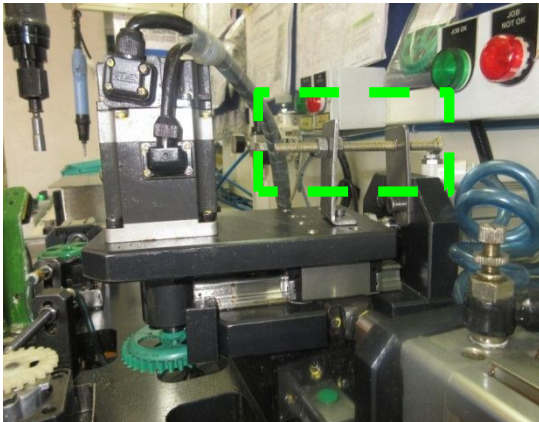
AFTER

RESULT:- 1. Setup time reduced from 15 minutes To 5 minutes
2. Break down eliminated

COUNTERMEASURE:- stopper arrangement made at top side of slide by providing 2 angles & a bolt for stroke control
