IK	TPM CIRCLE NO :-	04	ACTIVITY		KK		QM		PM		JH		SHE		OTPM		DM		E & T		KAIZEN IDEA SHEET
	TPM CIRCLE NAME	Josh	LOSS NO./STEP																		
Plant : P3	DEPT :	Maint.	RESULT AREA	C	Q	P	P, C	S	M, D	P, C	M										
CELL :	CELL NAME :				MACHINE STAGE:							OPERATION:									
KAIZEN THEME :	KAIZEN IDEA :	Contingency Plan																			
To Increase MTBF											BENCHMARK:	30 Min									
											TARGET:	60 Min									
PROBLEM PRESENT STATUS :	COUNTERMEASURE:											KAIZEN START:	05.01.2018								
In the past Some time fuel cock Assy. plate fitment m/c Electric screw driver not working, due to some time screw driver heating more than time continuous running and failure. That's by many Minor line stoppage Problem facing.	Now we are provided fuel cock plate fitment machine contingency plan, so we are provided one standby electric screw driver on Machine. Now no line stoppage problem										TARGET DATE:	05.01.2018

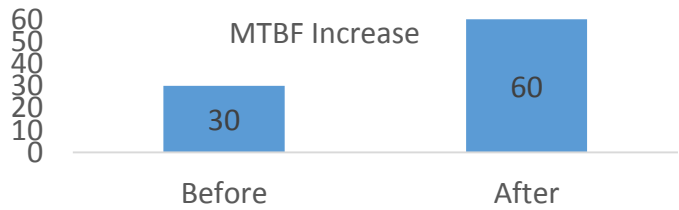
KAIZEN FINISH:	05.01.2018									
											TEAM MEMBERS:										
											Shubham Singh										
											Vikas Kumar										
											BENEFITS:-	Delivery improved									
WHY-WHY ANALYSIS:	BEFORE	AFTER	KAIZEN SUSTAINANCE																		
WHY :- Screw driver frequently fail WHY :- Heating problem WHY :- Continuous running

WHAT TO DO:	Check working condition																	
			HOW TO DO:	During PM activity																	
			FREQUENCY:	PM Schedule																	
			SCOPE & PLAN FOR HORIZONTAL DEPLOYMENT																		
			SR.NO.	CELL/PRODUCT	TDC	RESP.	STATUS														
ROOT CAUSE:-	RESULTS:																				
Continuous running											HD SCOPE INFORMATION IN OTHER PLANT										
											SR.NO.	PLAN T	WHEN	WHO M	STATUS						
REGISTRATION NO.: P3/PM/2018/001																					
DATE: 14.3.18																					
REGISTERED BY: Bipin Dixit
