CELL :- A177 | CELL NAME :- Oil pump | MACHINE / STAGE :- Flushing | OPERATION :- flushing

KAIZEN THEME :- To improve 3 S , And safety

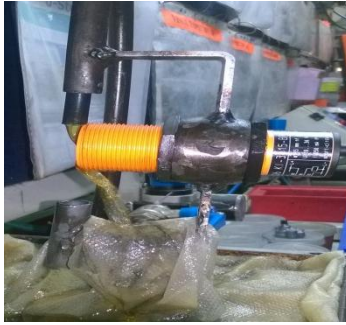
BEFORE

PROBLEM / PRESENT STATUS :- shop floor Is very dirty.

WHY - WHY ANALYSIS :-
WHY 1:- ANS 1:- shop floor Is very dirty.
Ans. Due to extra angle mount on drain

ROOT CAUSE :-
extra angle mount

COUNTERMEASURE :-
Cut the extra angle .

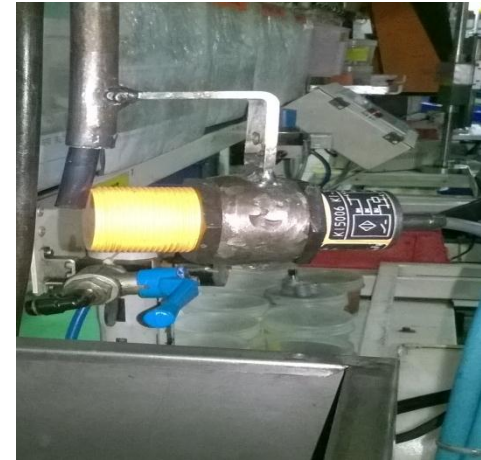
AFTER

RESULT :-
1- A177 line flushing floor area is clean .
