CELL :-A456 CELL NAME:-cobi Brake Assy MACHINE / STAGE:-Traceability process OPERATION :- Batch code marking

KAIZEN THEME :- To Avoid A456 Plate Traceability marking wrong direction.

CELL :- A456-II | CELL NAME:- CBS assembly | MACHINE / STAGE:- Hex-nut tightening | OPERATION :- 40

KAIZEN THEME :- to arrest arm comp lever inside bend

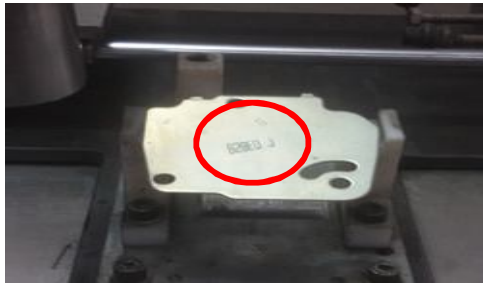
BEFORE

PROBLEM / PRESENT STATUS :-To Avoid A456 Plate Traceability marking wrong direction.

WHY - WHY ANALYSIS :-
 Why 1 : To Avoid A456 Plate Traceability marking wrong direction.
 Why 2 : There is no supporting block of plate in current process

ROOT CAUSE :-There is no supporting block of plate in current process

COUNTERMEASURE:- Provided supporting block of plate in current process.

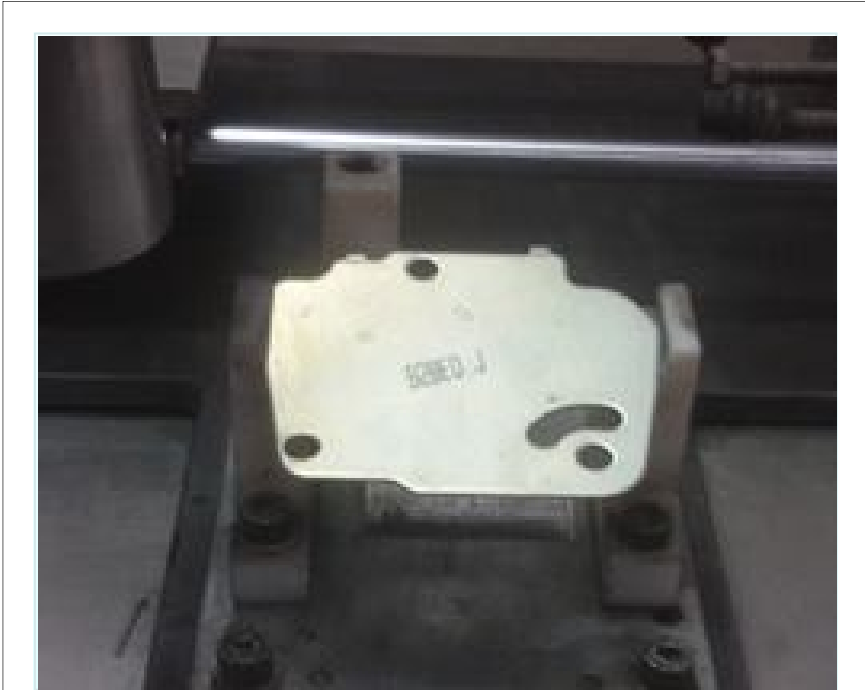
Before

- Inadequate fixture

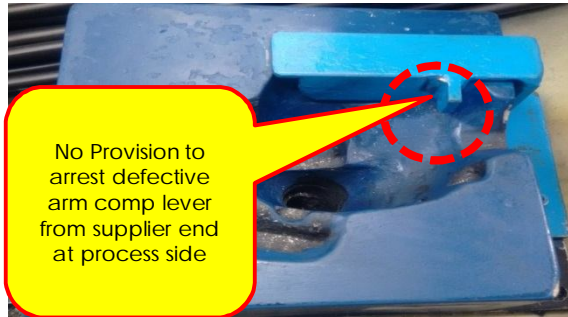
BEFORE

Probability of Arm comp lever Inside Bend

Why 2 - No Provision to arrest defective arm comp lever from supplier end at process side

Why 3 - fixture design not considered to arrest Arm comp lever Inside Bend

ROOT CAUSE :- Weak fixture design.

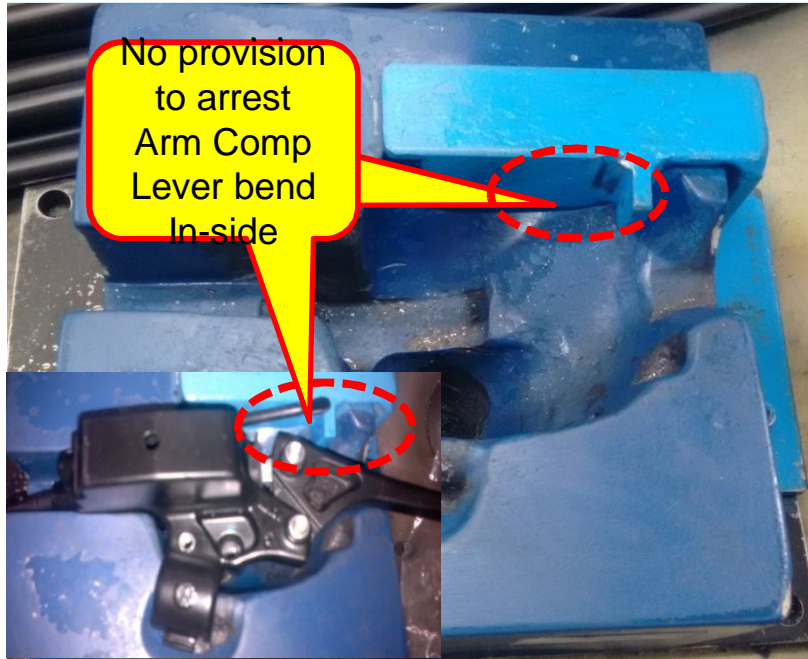
Before

- 1) No provision to arrest Angle –Inside Bend.
- 2) In-adequate Fixture

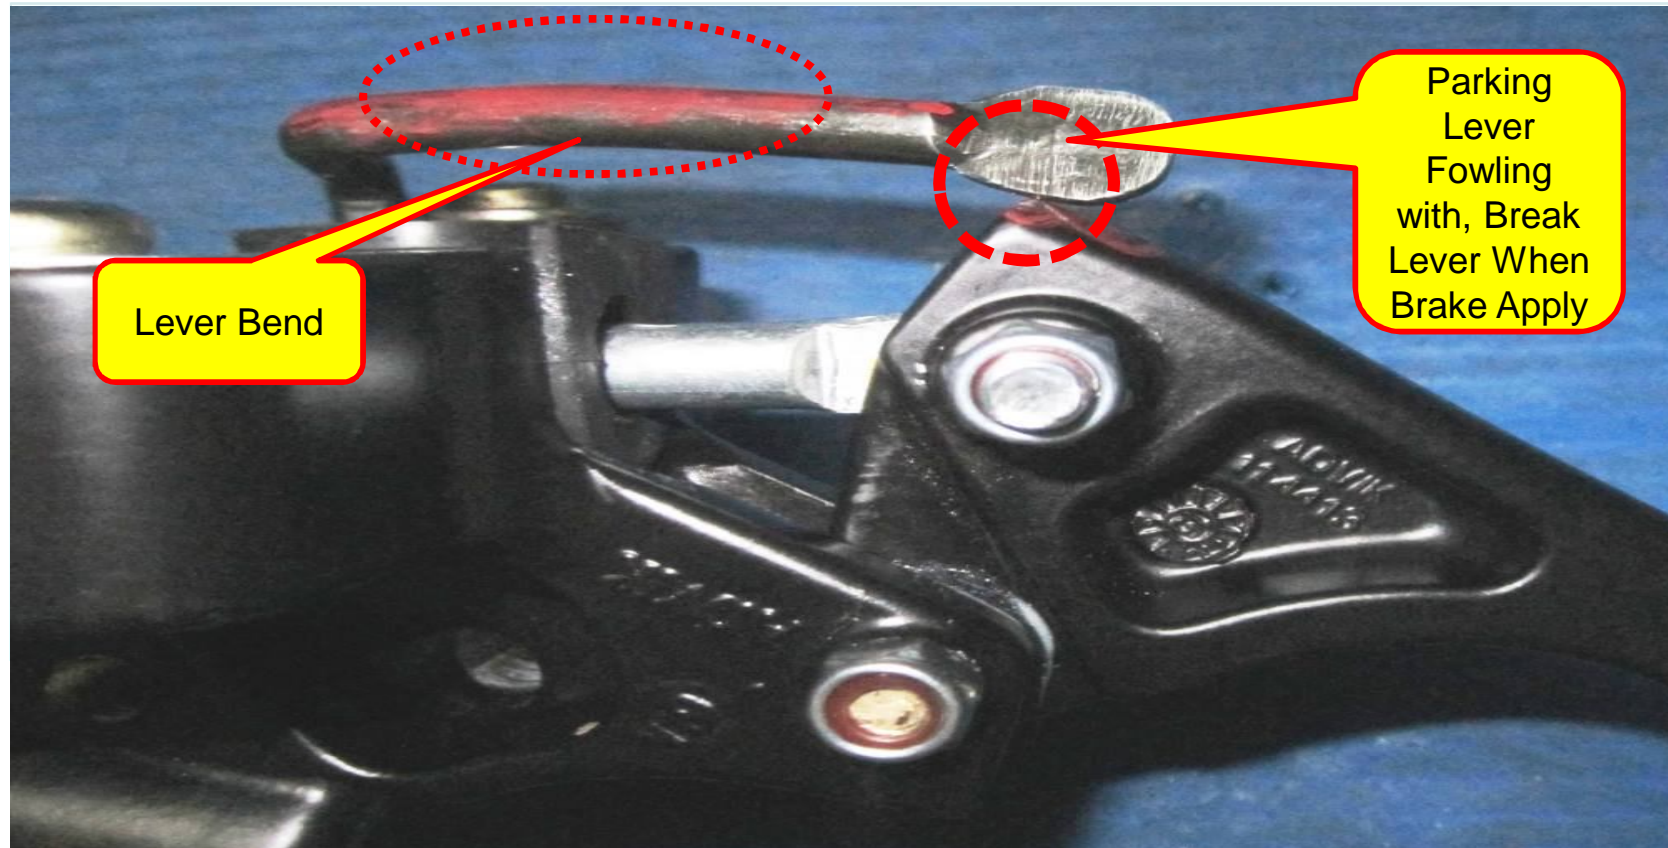
Defect:**Parking Lever Fowling with, Break Lever When Brake Apply**
