CELL :-A351      CELL NAME:- A351 machining      MACHINE / STAGE :- A351 1st VMC (Dart Plus)      OPERATION :- Op. 50Stage

**KAIZEN THEME :** To Prevent defect of Drum Change damage at Soft Cell

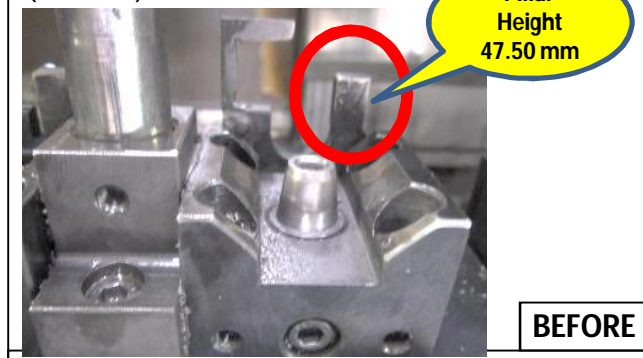
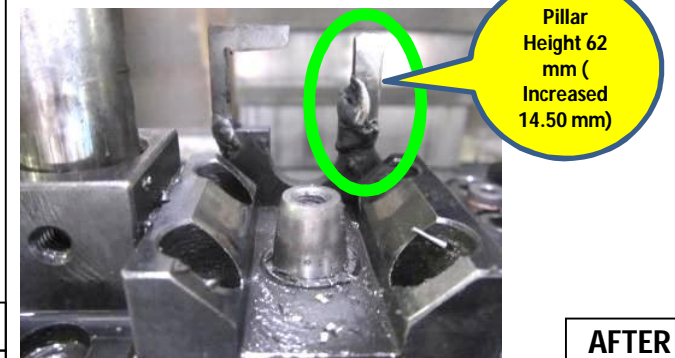
**PROBLEM / PRESENT STATUS :-** 6 Nos. A351Drum Change damaged at Soft Cell. (1<sup>st</sup> VMC).

**WHY - WHY ANALYSIS :-**  
**Why 1 :** 6 Nos. A351Drum Change damaged at Soft Cell (1<sup>st</sup> VMC).  
**Why 2 :** Damage because of Center Drill offset.  
**Why 3 :** Component clamped at wrong position.  
**Why 4 :** Component can be clamp at wrong position.  
**Why 5 :** Weak Poka Yoke Design

**ROOT CAUSE :-** Weak poke yoke Design

**COUNTERMEASURE:-** Changed the existing Poka Yoke Plate design by increasing its side pillar height from 47.50 mm to 62.00mm (Increased height 14.50 mm), so that component could not clamp at wrong position
