TPM CIRCLE NO :- 1	ACTIVITY	KK	QM	PM	JH	SHE	OT	DM	E&T
TPM CIRCLE NAME : Josh	LOSS NO. / STEP								
DEPT :- Maintenance	RESULT AREA	P	Q	DEF :- A	C	D	S	M

CELL :- A128      CELL NAME :- Tensioner Machining      MACHINE / STAGE :- A128 Tensioner Machining Line      OPERATION :- CNC Machining

**KAIZEN THEME :** To Prevent defect of M6 Thread miss in Tensioner Body during Machining.

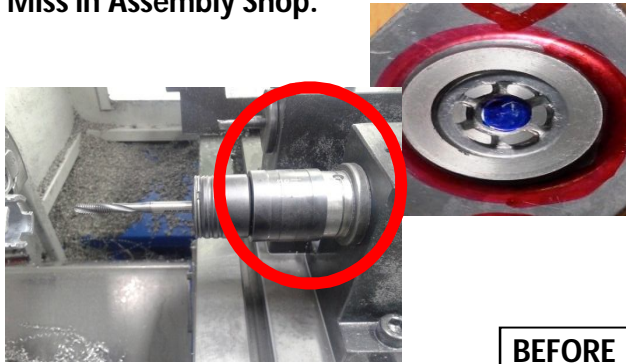
BEFORE

**PROBLEM / PRESENT STATUS :-** 1 No. Tensioner Body observed with M6 Thread Miss in Assembly Shop.

**WHY - WHY ANALYSIS :-**  
**Why1:** M6 Thread Miss in Tensioner Body.  
**Why2:** M6 Threading not done by M6 Tap  
**Why3:** M6 Tap gone for Tapping and without Tapping come back in Home Position.  
**Why4:** Heavy Flash on pre-cast hole.

**ROOT CAUSE :-** Heavy Flash on pre-cast hole.
