CELL :- A491	CELL NAME:- Auto Fuel Cock	MACHINE / STAGE :- Toggle Press /Assy.	OPERATION :- Operation No. 10
--------------	----------------------------	--	-------------------------------

KAIZEN THEME : To Prevent the may happen in house rejection of A491 AFC in cover blockage testing at assy. cell.

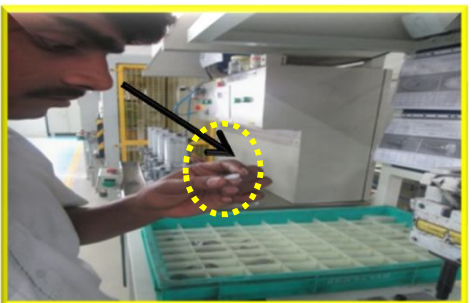
BEFORE

PROBLEM / PRESENT STATUS :- May happen in house rejection in cover blockage testing due to retainer hole $\varnothing 0.25 \pm 0.05$ presence & blockage inspection method it is not effective .

WHY - WHY ANALYSIS :-
Why1: May Happen In house rejection at cover blockage testing.
Why2 : Retainer hole $\varnothing 0.25 \pm 0.05$ hole miss & Blockage.
Why 3:- Visual Inspection method was not effective.

ROOT CAUSE :- Visual Inspection method was not effective.
