CELL :- A431 **CELL NAME:- CBS** **MACHINE / STAGE:-Welding stage** **OPERATION :- 20**

KAIZEN THEME : To Prevent the customer complaint : 2LP Decomp assy functional problem at Engine assy @ Yamaha

CELL :- A456 CELL NAME:- CBS MACHINE / STAGE:-Welding stage OPERATION :-60

KAIZEN THEME : To Prevent the customer complaint : A456 CBS Assy functional problem at sub Assy (Handle Assy) at HMSI-3F.

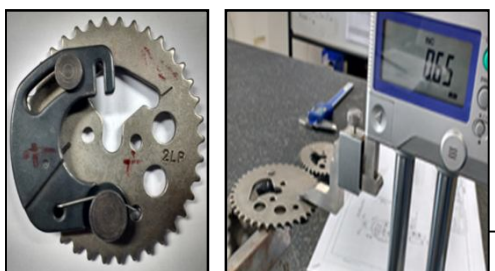
BEFORE

PROBLEM / PRESENT STATUS :-
To Prevent the customer complaint : 2LP Decomp assy functional problem at Engine assy @ Yamaha

- Why 1** - 2LP Decomp Assy functional problem at Engine Assy @ Yamaha
- Why 2** - Decomp assembly fly-weight movement hard
- Why 3** - Less clearance in between sprocket & flyweight
- Why 4** - Rivet height observed less as against spec. (1± 0.2)
- Why 5** - Excess load applied on shaft1 during riveting process
- Why 6** - Height adjusted on trial & error basis during tool setting
- Why 7** - No height master provided (28.50mm)

ROOT CAUSE :No height master provided (28.50mm)

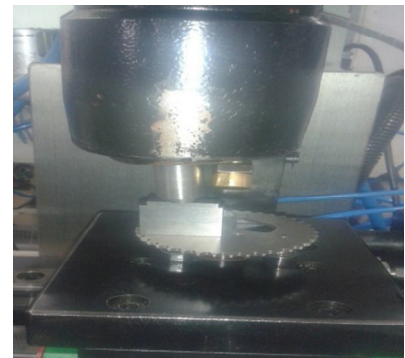
AFTER

IDEA :- Height master provided (28.50mm)

Countermeasure :-
To provided Height Master for riveting process during setting .(TDC – 18.11.2015)

WHAT TO DO : WI Updated
HOW TO DO : During setting time check with master .
FREQUENCY :- Once in shift .

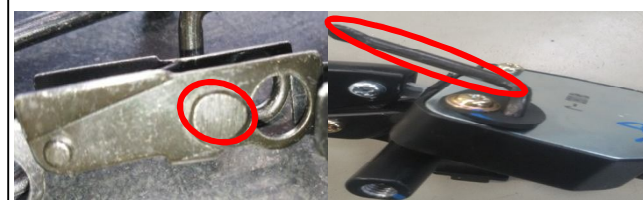
BEFORE

PROBLEM / PRESENT STATUS :-
To Prevent the customer complaint : A456 CBS Assy functional problem at sub Assy (Handle Assy) at HMSI-3F.

WHY - WHY ANALYSIS :-
Why 1 - A456 CBS Assy functional problem at sub Assy (Handle Assy) at HMSI-3F.
Why 2 - CBS Assy Arm Comp - Parking Lock Free Movement NG (Slow)
Why 3 - The arm comp movement slow in assembly due to foul on face of - Bracket
Why 4 - Arm comp welding excess flow fouling with bracket face while assembly .
Why 5 - Welding overflow (No Control Over weld bead-travelling) (welding dia more)

ROOT CAUSE : Operator maintained welding dia O/S due to past complaint (Weak welding / Weld broken).

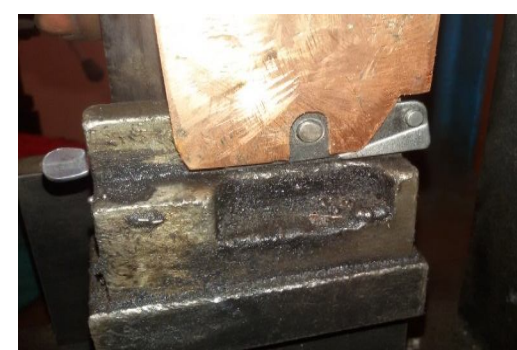
AFTER

IDEA : -Welding dia should be OK.

Countermeasure:- Provided the copper strip in welding fixture to avoid the welding dia O/S

WHAT TO DO : W I modified
HOW TO DO : Check with limit sample
FREQUENCY : - Once in shift .
