CELL :- A456 **CELL NAME:-** CBS Assy **MACHINE / STAGE:-** Lever Assy-OP-60 **OPERATION :-**Lever Assy

KAIZEN THEME : To Prevent the customer complaint for A456 CBS Assy (KWPJ) functional problem at Assy frame (Switch Assy) in HMSI 3F.

CELL :- A456 **CELL NAME:- CBS** **MACHINE / STAGE:-Supplier End(Sri Ram)** **OPERATION :-Grinding**

KAIZEN THEME : To Prevent the defect of arm comp Poor function in CBS assembly.

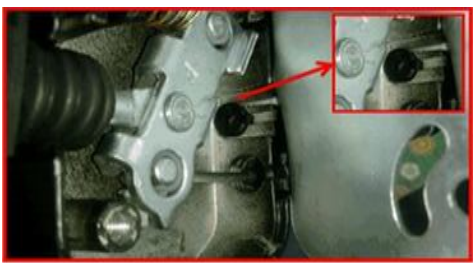
BEFORE

PROBLEM / PRESENT STATUS :-
To Prevent the customer complaint for A456 CBS Assy (KWPJ) functional problem at Assy frame (Switch Assy) in HMSI 3F.

WHY - WHY ANALYSIS :-
Why 1 – Switch cable plunger broken at A456 Lever Assy
Why 2 - Equalizer may foul with switch plunger during Pivot-1 tightening at lever assembly.
Why 3 - The Gap between the Equalizer & Switch plunger is less at lever assembly may cause the plunger damage or broken.
Why 4 - Inadequate design of fixture

ROOT CAUSE :
Inadequate design of fixture

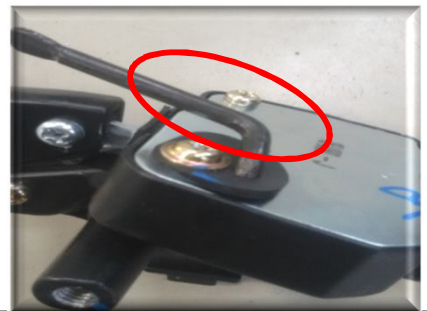
BEFORE

PROBLEM / PRESENT STATUS :-
To Prevent the customer complaint : A456 CBS Assy functional problem at sub Assy (Handle Assy) at HMSI-3F.

WHY - WHY ANALYSIS :-
Why 1 -5 no's Arm comp movement found with poor function at FI Stage.
Why 2 - Arm comp touches to Cover plate.
Why 3 Arm comp rest on High surface of bracket.
Why 4 - Arm comp welding height 2mm Max o/s by 0.9mm

ROOT CAUSE :Arm comp welding height 2mm Max o/s by 0.9mm
