TPM CIRCLE NO :-		ACTIVITY		KK	QM	PM	JH	SHE	OTPM	DM	E & T	KAIZEN IDEA SHEET		
TPM CIRCLE NAME :		LOSS NO./STEP		14										
Plant : P14		DEPT :	Maintenance	RESULT AREA	C	Q	P	P, C	S	M, D	P, C		M	
CELL :-	Assembly shop	CELL NAME :	Tensioner A467		M/C STAGE:	SPM			OPERATION:		Testing			
KAIZEN THEME :		KAIZEN IDEA :												
To improve the quality avoid the NG		Increase the clearence							BENCHMARK:					
									TARGET:		0 No's			
									KAIZEN START:		20.03.2018			
PROBLEM PRESENT STATUS :		COUNTERMEASURE:							TARGET DATE:		20.03.2018			
Leak test NG frequently came healthy part also		Bottom tool and component clearance very low. So that purpose now increase the 10mm depth in bottom tool and than checked than ok. Compare to now rejection occurrence is very less							KAIZEN FINISH:		20.03.2018			
									TEAM MEMBERS:					
									Ganesan		Dhasarath			
									Mallikarjun					
WHY-WHY ANALYSIS:		BEFORE			AFTER				BENEFITS:-

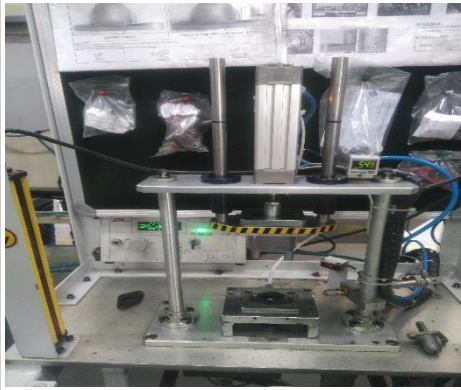
<p>Why1:- Leak testing frequently NG</p> <p>Why2:- Repeatability issue happen</p> <p>Why3 :- Component length and bottom fixture length clearance nill</p> <p>Why3: Free space not available</p>

<p style="text-align: center;">Q not ok Healthy condition</p> <p style="text-align: center;">Before After</p>			SR. No		CELL/ PRODUCT		TDC		RESP.		STATUS	
					1									
REGISTRATION NO.:		P14/QM/2018/039		HD SCOPE INFORMATION IN OTHER PLANT										
DATE:		28.03.2018												
REGISTERED BY:		Mr. Nigama												
MANGERS SIGN:		Mr. Dinesha M
