## **Process Side Improvement**

**Problem Description 1** :- Daily segrigation of rotor in model wise due to Rotor miss from bins and collected in coolant tank .

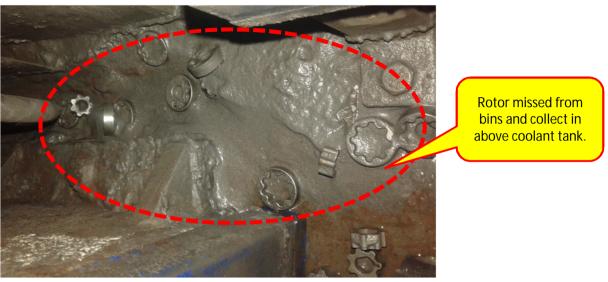
Why 2 – It happened during lift of bins in machine.

Why 3 – Improper handling of bins after grinding.

**Root Cause :**– Improper handling of bins after grinding.

Kaizen Idea :- Provide meshed sheet box

Countermeasure - Provide meshed sheet box to collect all rotor inside box.
