KAIZEN IDEA SHEET

CELL: A467 **CELL NAME:** Tensioner assy **MACHINE / STAGE:-** Leak Testing Machine **OPERATION:** Leak Testing

KAIZEN THEME: To Eliminate Air Pressure regulator drop

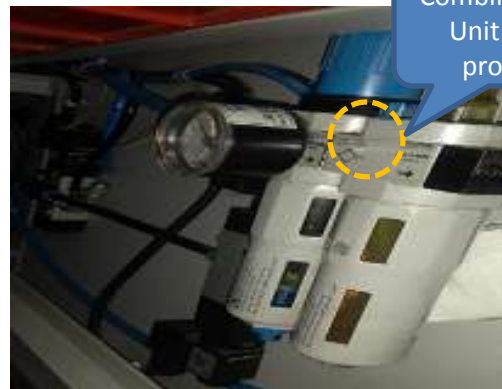
BEFORE

PRESENT STATUS:- During Leak testing operation Air pressure not properly accumulated.

- Why1:-** Leak testing found NG
- Why2:-** Air pressure not accumulated
- Why3:-** Separate FRL Unit not presence

ROOT CAUSE:- :- Single FRL Unit not presence for Leak testing operation

IDEA:- Separate FRL Unit require for Leak Testing operation

COUNTERMEASURE:- Provided Single FRL Unit only for leak testing rig to avoid Pressure accumulation problem.

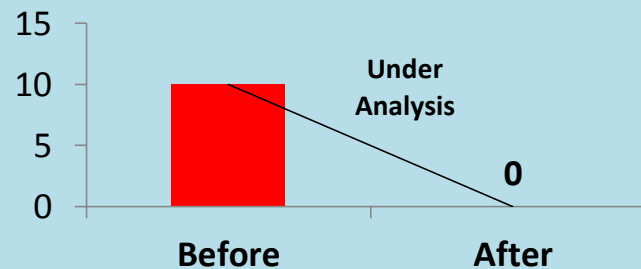
Rejection Quantity at Leak testing operation

RESULT:Quality of Leak testing operation Improved
