CELL :- A247 L	CELL NAME:- Lever	MACHINE / STAGE :- SPM	OPERATION :- Tapping.
----------------	-------------------	------------------------	-----------------------

KAIZEN THEME –To avoid A247 Lever Dia. 6.3 hole face damage

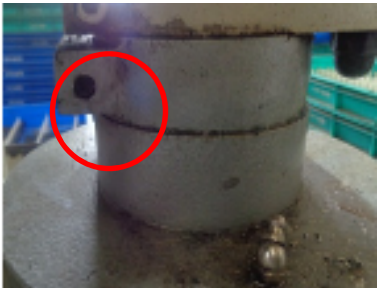
BEFORE

PROBLEM / PRESENT STATUS –A247 Lever Dia. 6.3 hole face damage

Bolt loose

- Why 1** – A247 Lever Dia. 6.3 hole face Damage .
- Why 2** – M5 Tap dash on Dia 6.3 hole face.
- Why 3** – M5 Tap & Dia 4.2 hole alignment mismatch
- Why 4** – M5 tapping unit rotate.
- Why 5** – M5 Tapping head locking bolt loose.
- Why 6** – Weak design .

ROOT CAUSE- – Weak design .

IDEA :- Design to be change as lock nut to be fitted to avoid loose bolting .

COUNTERMEASURE: 1) Lock nut fitted to avoid loose bolting .
 2)Alignment done, Marking done on unit.
 3)Check point added in JH &PM Check sheet.

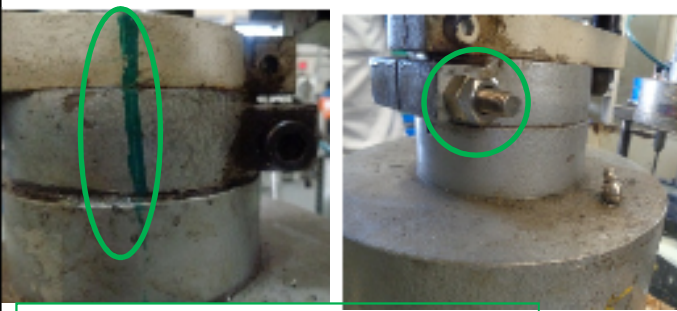
AFTER

Additional fitted to avoid loose bolting
