Best kaizen- PM

TPM CIRCLE NO :-		ACTIVITY	KK	Q/M	PM	JH	SHE	OTPM	D/M	E & T	KAIZEN IDEA SHEET		
		TPM CIRCLE NAME :		LOSS NO./STEP	14										
Plant : P14		DEPT :	Maintenance	RESULT AREA	C	Q	P	P, C	S	M, D	P, C	M			
CELL :-	Machine shop	CELL NAME :	Drum gear shifter	M/C STAGE:	Drum gear washing			OPERATION:		Washing					
KAIZEN THEME :		KAIZEN IDEA :													
To improve the quality		Less gap of supporting plate							BENCHMARK:						
PROBLEM PRESENT STATUS :		COUNTERMEASURE:							TARGET:						
Improper cleaning process		Removed the fixed supporting plate from machine & made a groove in the side angle rod closer to the job.							KAIZEN START:		14.06.18				
WHY-WHY ANALYSIS:		BEFORE			AFTER			TARGET DATE:		15.06.18					
<p>Why1:- Improper cleaning process</p> <p>Why2:- Job not seating on nozzles</p> <p>Why3 :- No proper supporting</p> <p>Why4 :- More gap between supporting plate & job.</p>

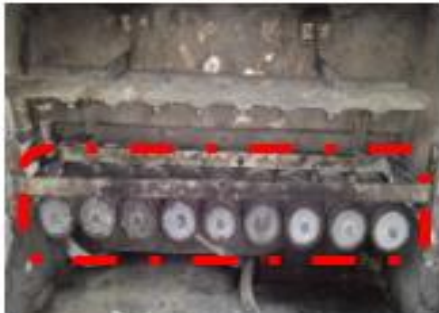
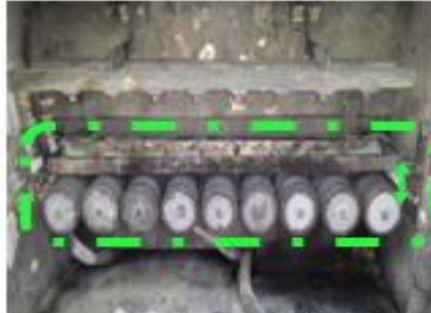
ROOT CAUSE		RESULTS:			SCOPE & PLAN FOR HORIZONTAL DEPLOYMENT										
More gap of supporting plate		1.Reduced the plate gap from 64 mm to 10 mm			SR. No		CELL/ PRODUCT		TDC		RESP.		STATUS		
REGISTRATION NO.:
