CELL :- D.C. CELL NAME:-Drum change All models MACHINE / STAGE:- VMC spark machine. OPERATION:- 5-Hole drilling.

KAIZEN THEME :- To increase the MTBF of Hole Seal.

IDEA :-To make Bush from PU material

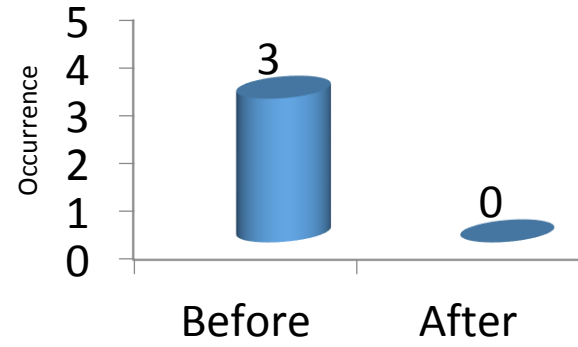
- WHY 1:- O ring removed in every 2 hours.Aprox.
- WHY 2:- Which was not fixed with hole.
- WHY 3:-It was made from rubber material.

RESULT :- No stoppage

ROOT CAUSE :- O Ring made from Rubber material

COUNTERMEASURE:-Changed the o ring of Rubber and using PU bush at Drilling & Tapping A352 & A422 Resting ring above the metallic face of 5-hole drilling fixture, then if any metallic chips comes on the drilling fixture then air pressure not drop and reach the specific pressure which use for prevention of 5 depth over size of drum change all models
