CELL :- A247 L	CELL NAME:- Lever	MACHINE / STAGE :- SPM	OPERATION :-Tapping
----------------	-------------------	------------------------	---------------------

KAIZEN THEME -To Avoid A247 Lever Ø 6.3 hole shift.

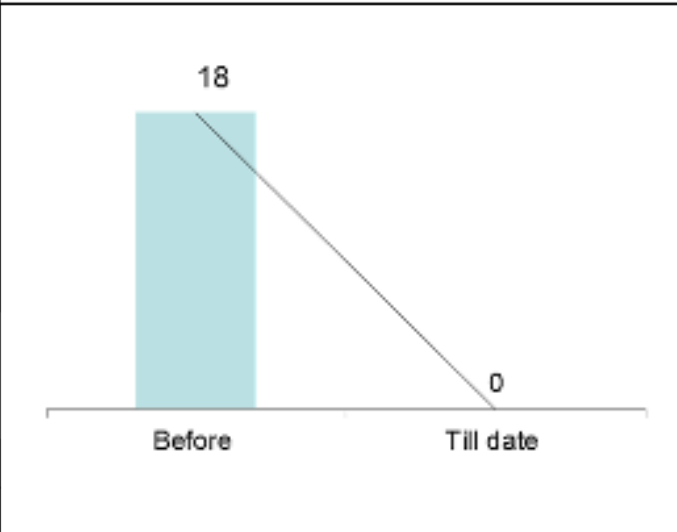
RESULT :-

- WHY - WHY ANALYSIS :-**
- Why 1** - A247 Lever Ø 6.3 hole shift.
 - Why 2** - Part not clamp.
 - Why 3** - Clamp pad broken.
 - Why 4** - Excess load act on pad.
 - Why 5** - Gap between clamp strip & clamping pad.

ROOT CAUSE- Gap between clamp strip & clamping pad

COUNTERMEASURE : Clamping strip & clamping pad gap done zero by modifying clamping pad .
