CELL :-Assy CELL NAME:-A337/271 M/C STAGE :-Oil Pump OPERATION :-Free Rotation & Flushing

KAIZEN THEME :- MTBF to be improve

IDEA :- Stopper location to be shift

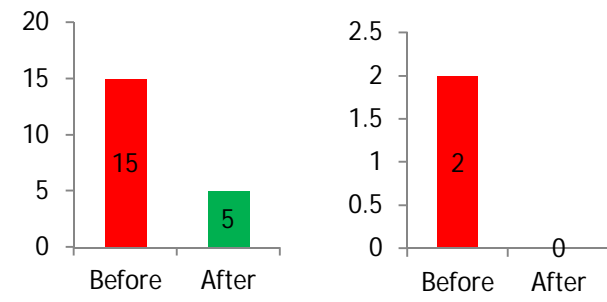
PROBLEM / PRESENT STATES:- Stopper provided at the bottom side of cylinder for stroke control which is getting direct contact with LM guide, it intern causing damage on LM guide, & even Hard to set while setup change as there is less space for hand movement.

- Why1 :-** Shifted the location of stopper.
- Why2 :-** Slide getting jam
- Why3 :-** Lm guide damage
- Why4 :-** Direct contact with the stopper

ROOT CAUSE :- wrong design

COUNTERMEASURE:- stopper arrangement made at top side of slide by providing 2 angles & a bolt for stroke control

RESULT:- 1. Setup time reduced from 15 minutes To 5 minutes
2. Break down eliminated
