CELL :-A456 CELL NAME:-cobi Brake Assy MACHINE / STAGE:-Traceability process OPERATION :- Batch code marking

KAIZEN THEME :- To Avoid A456 Plate Traceability marking wrong direction.

CELL :- A456-II | CELL NAME:- CBS assembly | MACHINE / STAGE:- Hex-nut tightening | OPERATION :- 40

KAIZEN THEME :- to arrest arm comp lever inside bend

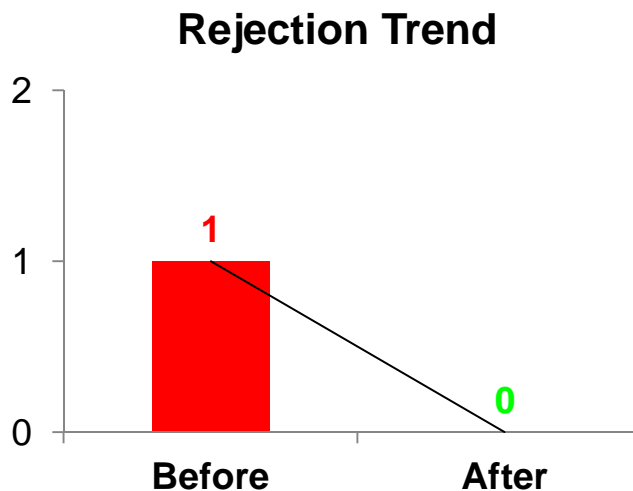
Why 2 - No Provision to arrest defective arm comp lever from supplier end at process side

ROOT CAUSE :- Weak fixture design.
