CELL :- A456 **CELL NAME:-** CBS Assy **MACHINE / STAGE:-** Lever Assy-OP-60 **OPERATION :-**Lever Assy

KAIZEN THEME : To Prevent the customer complaint for A456 CBS Assy (KWPJ) functional problem at Assy frame (Switch Assy) in HMSI 3F.

CELL :- A456 **CELL NAME:- CBS** **MACHINE / STAGE:-Supplier End(Sri Ram)** **OPERATION :-Grinding**

KAIZEN THEME : To Prevent the defect of arm comp Poor function in CBS assembly.

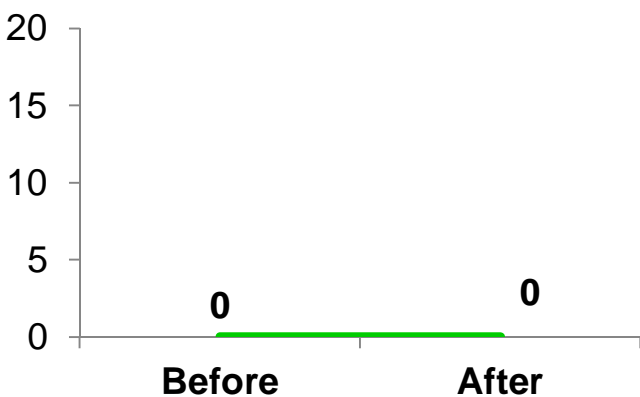
IMPROVEMENT

WHY - WHY ANALYSIS :-
Why 1 – Switch cable plunger broken at A456 Lever Assy
Why 2 - Equalizer may foul with switch plunger during Pivot-1 tightening at lever assembly.
Why 3 - The Gap between the Equalizer & Switch plunger is less at lever assembly may cause the plunger damage or broken.
Why 4 - Inadequate design of fixture

ROOT CAUSE :
Inadequate design of fixture

Countermeasure:- To change the exiting fixture by providing the Gap between the Equalizer & switch plunger to avoid the plunger being get hit by Equalizer .

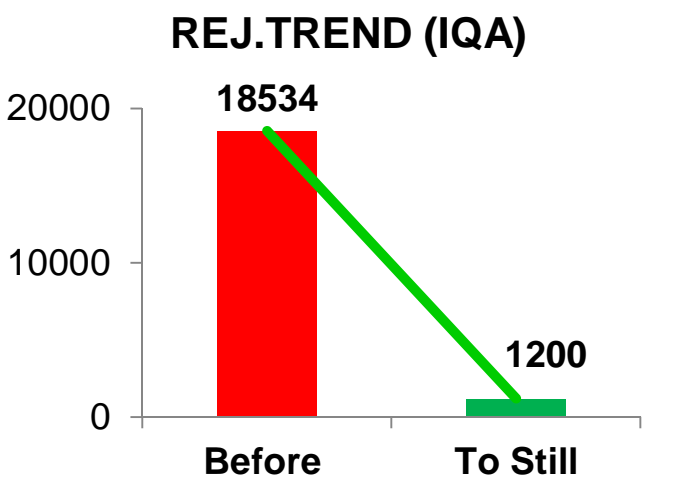
RESULT :-

WHY - WHY ANALYSIS :-
Why 1 -5 no's Arm comp movement found with poor function at FI Stage.
Why 2 - Arm comp touches to Cover plate.
Why 3 Arm comp rest on High surface of bracket.
Why 4 - Arm comp welding height 2mm Max o/s by 0.9mm

ROOT CAUSE :Arm comp welding height 2mm Max o/s by 0.9mm

Countermeasure:-100% Grinding process added after welding process.
