**CELL:-** Oil pump      **CELL NAME:-** A206 Body      **MACHINE / STAGE :-** VMC brother      **OPERATION :-** face milling, reaming

**KAIZEN THEME :** To eliminate A206 body chatter mark

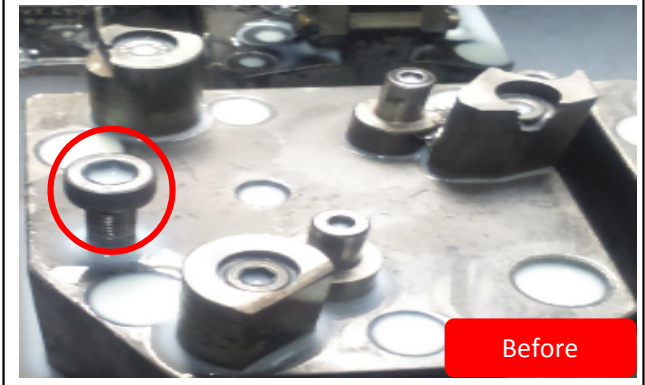
**Problem present status :-** A206 Body chatter mark

**Why1 :-** A206 body chatter mark.  
**Why2 :-** Part get vibrate during machining .  
**Why3 :-** Gap observed between resting bolt face & part face  
**Why4 :-** Resting bolt loose  
**Why5 :-** No locking of bolt.

**ROOT CAUSE :** No locking of bolt.

**COUNTERMEASURE:-**  
1. Resting bolt to be changed as locking to be provided to eliminate chatter mark defect .

Currently adjust bolt height & check 100 %
