CELL :- A285 **CELL NAME:-** Oil Pump Assly **MACHINE / STAGE :-** Assembly **OPERATION :-** Screw fitment

KAIZEN THEME : To eliminate the in-house rework.

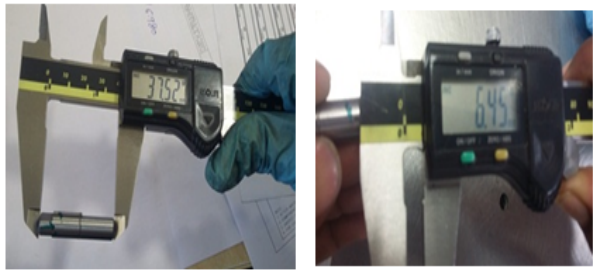
Problem present status :-A285 shaft total length 39.5 U/S by 2 mm.

Before

After

Why1 :-A285 assembly found reject at final inspection.
why2:- Shaft total length U/S.
Why3 :-Shaft dimension 8.5 mm U/S & found up to 6.45 mm
Why4 :- Not arrested in Inprocess of assembly.
Why4 :- No Poka.

ROOT CAUSE : No Poka

IDEA :-Provide pokayoke.

COUNTERMEASURE:- Sensor will be implemented at screw fitment stage & interlock with screw fitment gun.
